Your Inspection Report

123 Main Street
Addison, IL 60101

INSPECTION DATE:
Monday, August 16, 2021

Report No. 1418, v.2

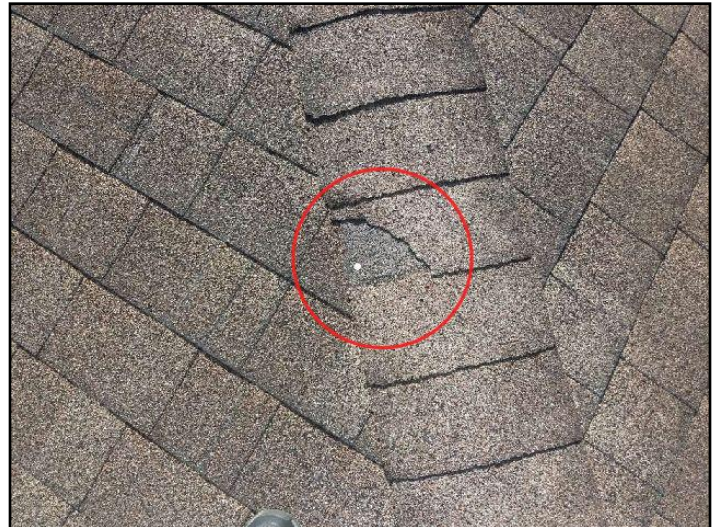
The roof has several deficiencies: There are torn shingles. The shingles show gradual loss. The ridges of the roof have significant deterioration.

Torn shingle

Task: Consult a qualified, licensed roofer for further evaluation and repairs or replacement, as needed

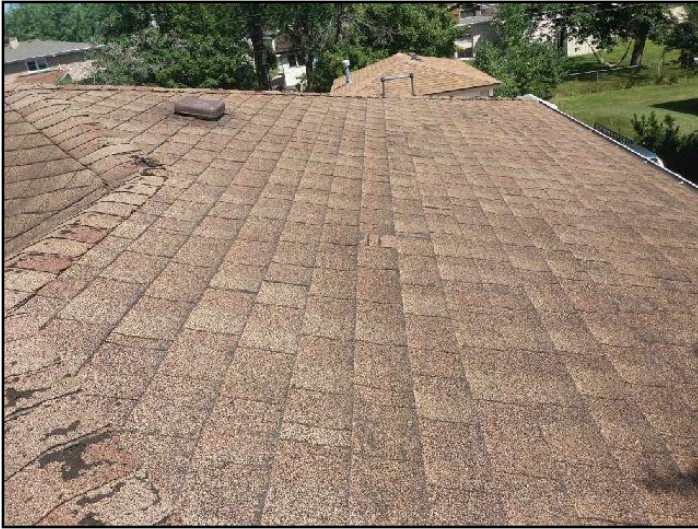
Granule loss

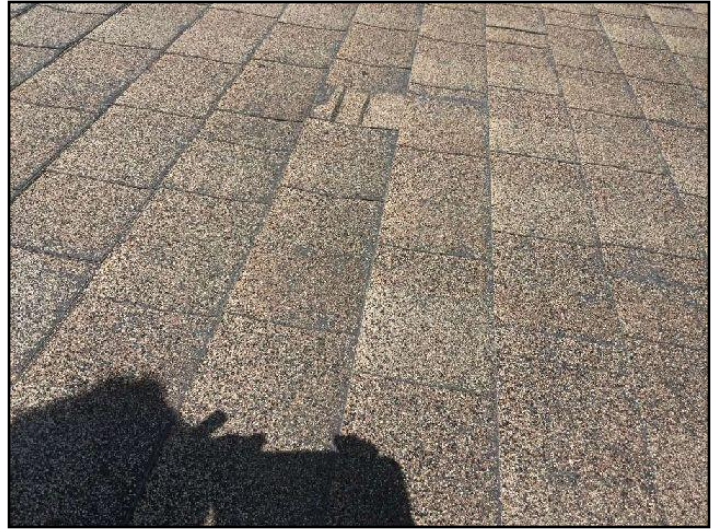
Granule loss

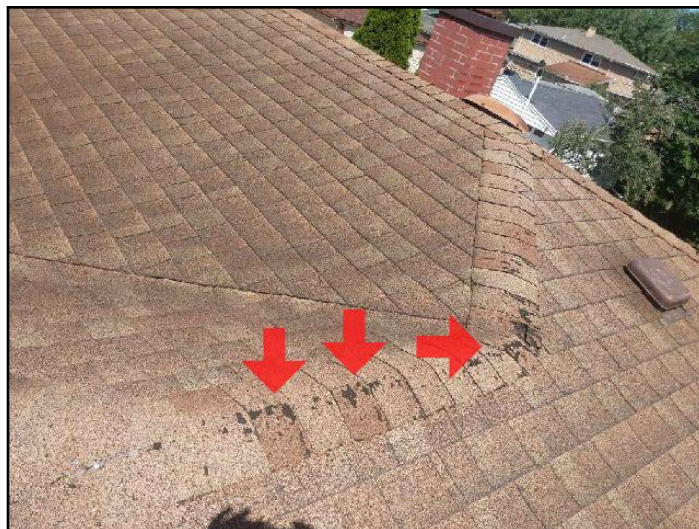
Ridge shingle deterioration

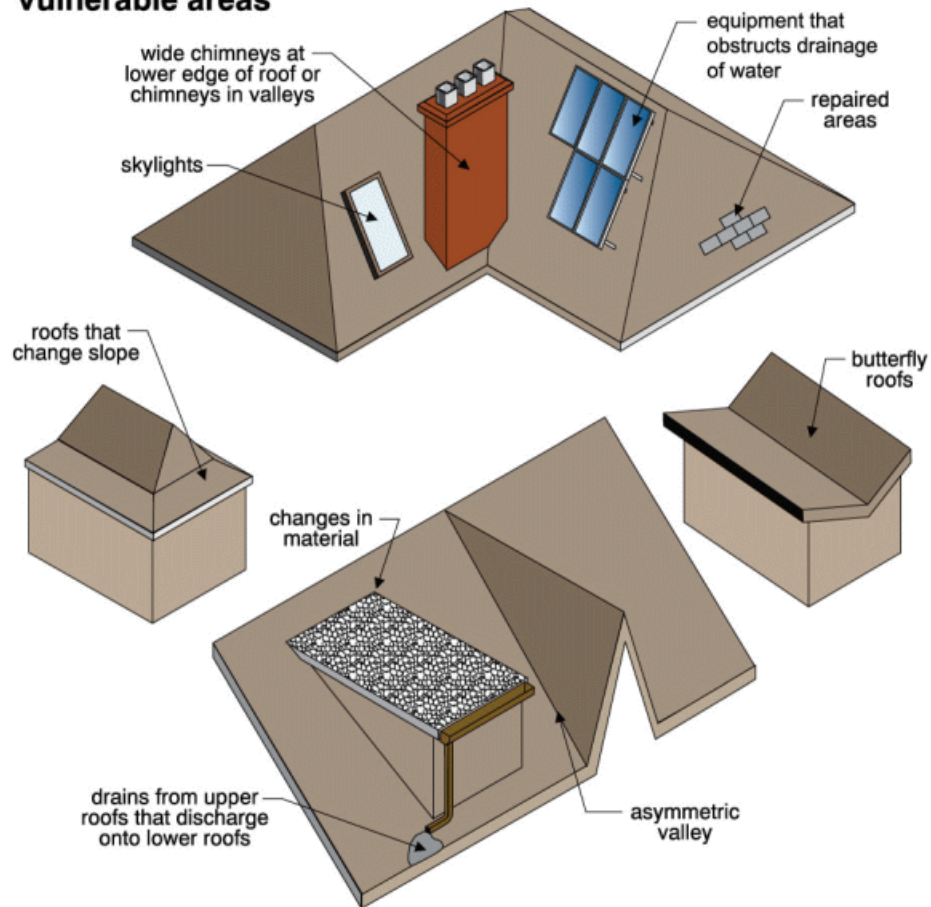
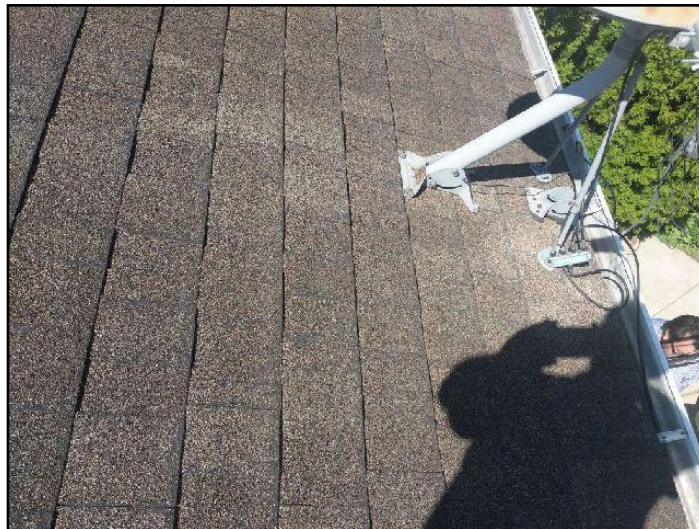
Fasteners of satellites leave vulnerable areas within the roof. Recommend removing satellite with repairs, as needed.

Vulnerable areas

Task: Consult a qualified, licensed roofer for removal and repair

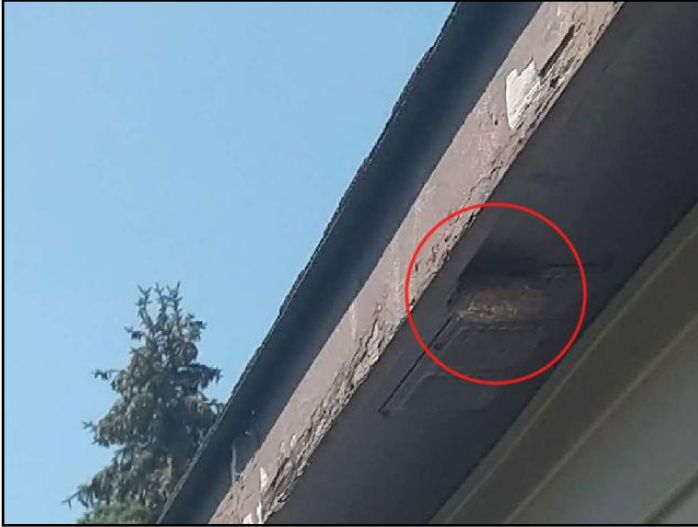
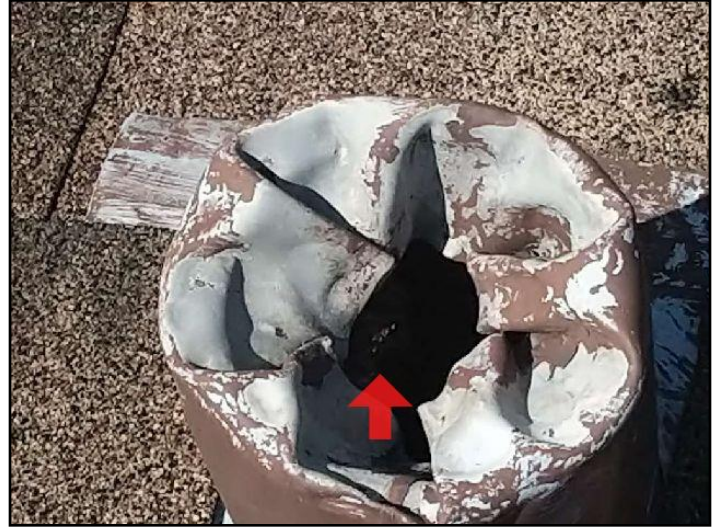
4. Condition: • Wasp nests.

Wasp nest

Task: Consult a qualified, licensed pest control contractor for repairs

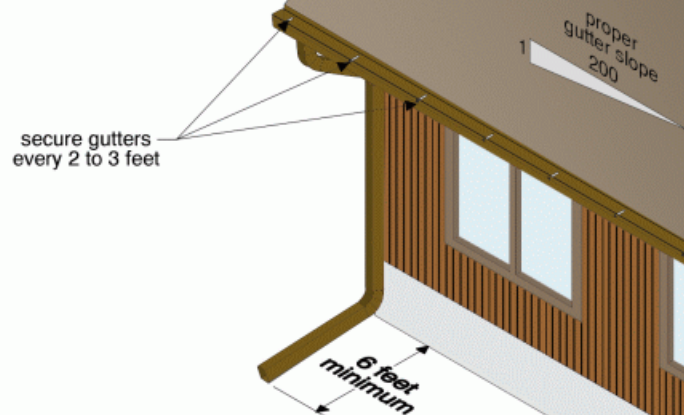
5. Condition: • [Should discharge 6 feet from building](#)

Downspout extension too short

Task: Consult a qualified, licensed gutter contractor for repairs

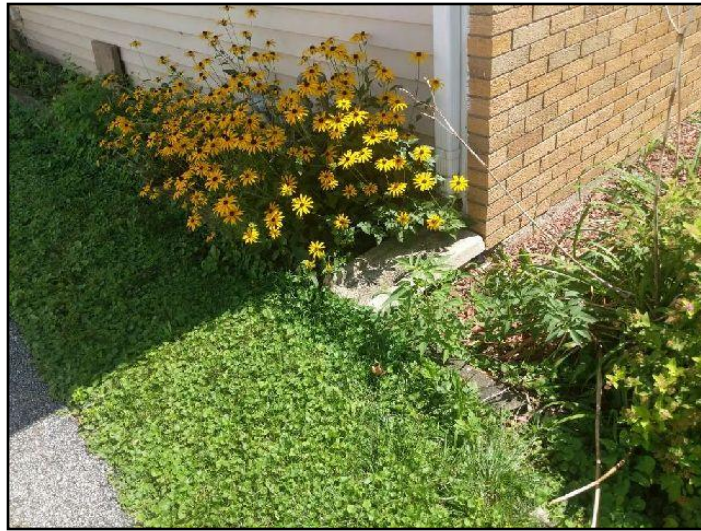
Should discharge 6 feet from building

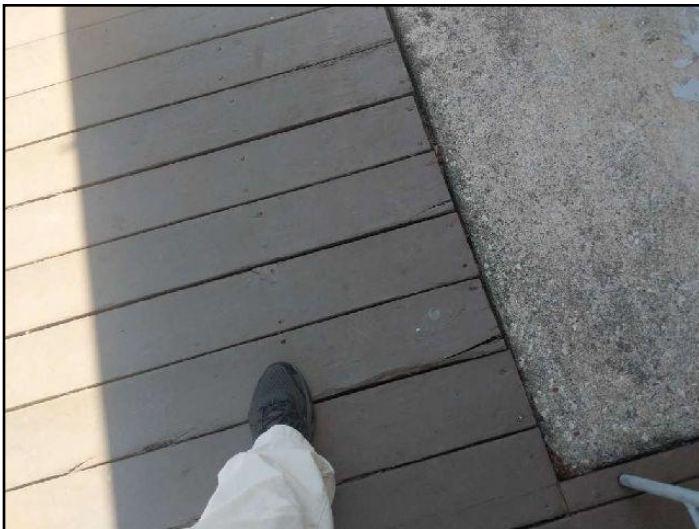
The porch landing has damage. Areas are soft or may have rot. Some boards are loose and end pieces are loose.

Loose boards

Task: Consult a qualified, licensed framer for repairs

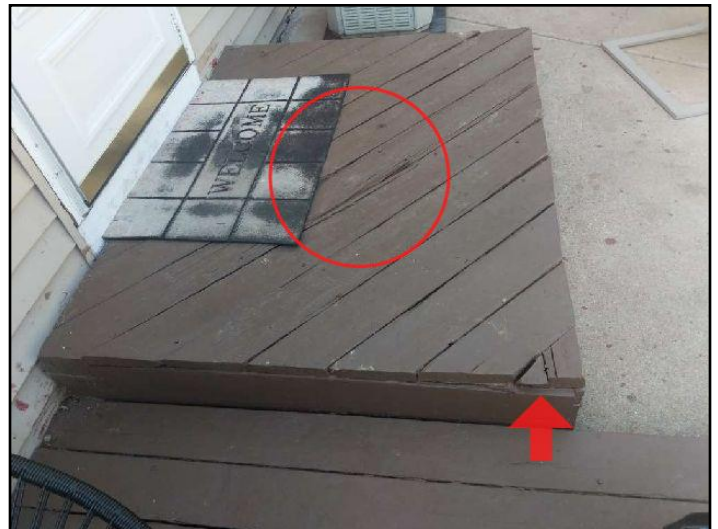
Soft boards/ damaged end piece

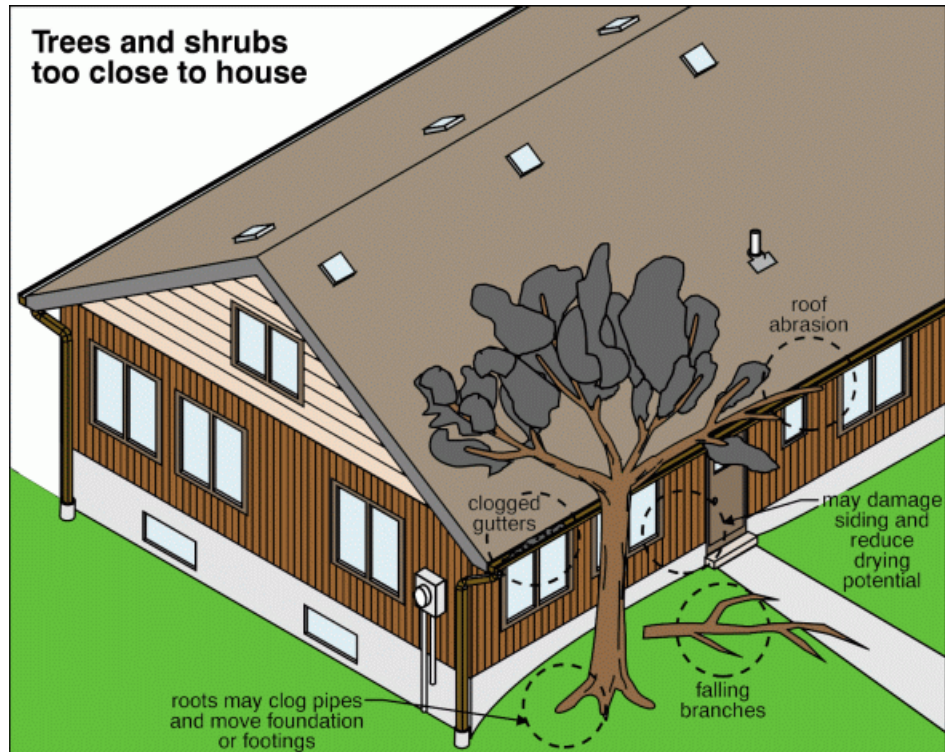
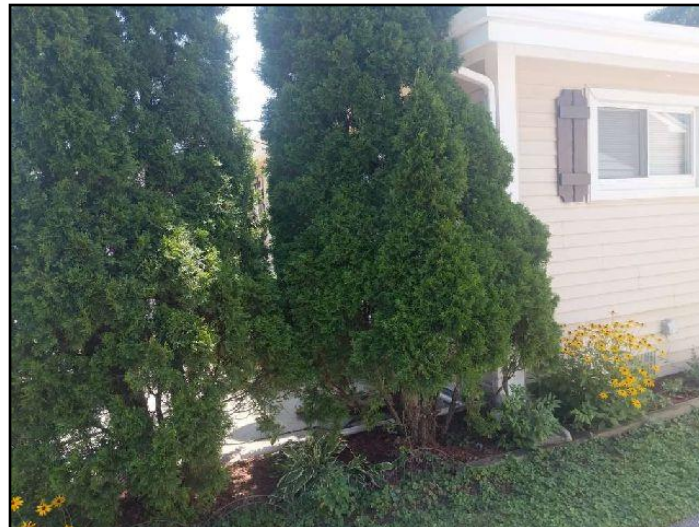
7. Condition: • [Trees or shrubs too close to building](#)

Implication(s): Chance of water damage to structure, finishes and contents | Chance of pests entering building | Material deterioration

Trees or shrubs too close to building

Task: Consult a qualified, licensed landscaper for repairs

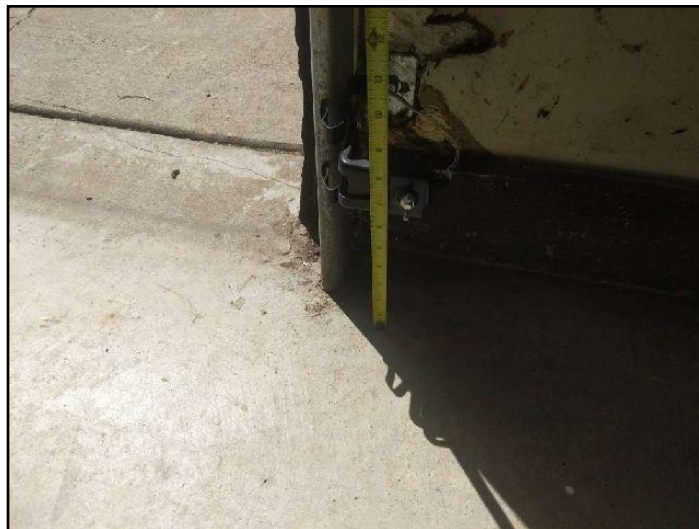
9. Condition: • Sensors poorly located

Sensors poorly located

Task: Repair

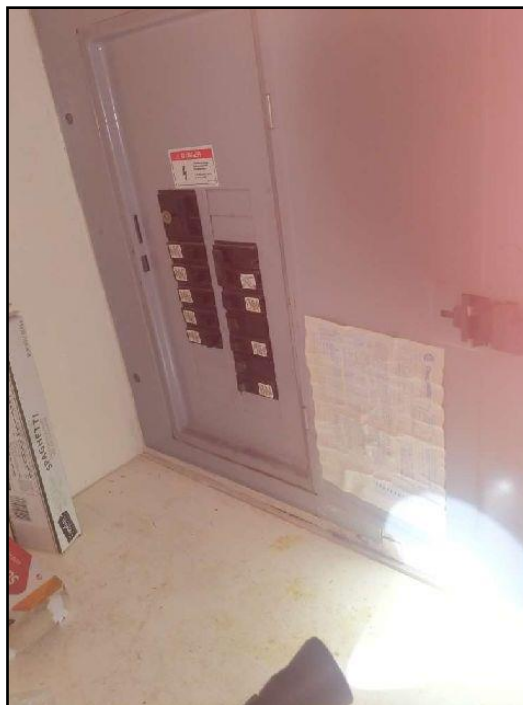
The circuits are not labeled at the panel

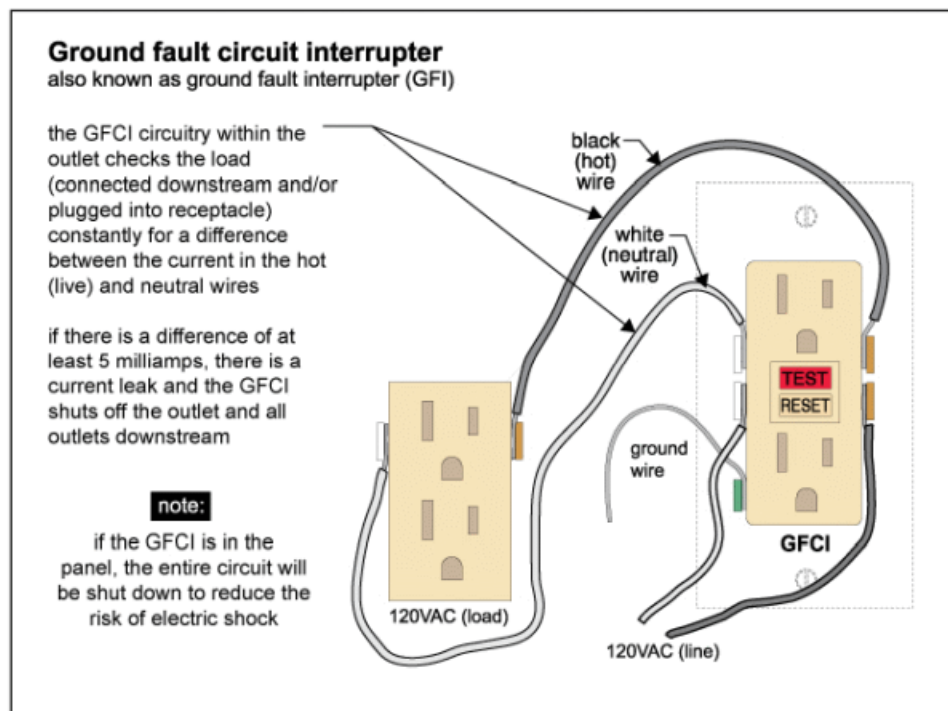
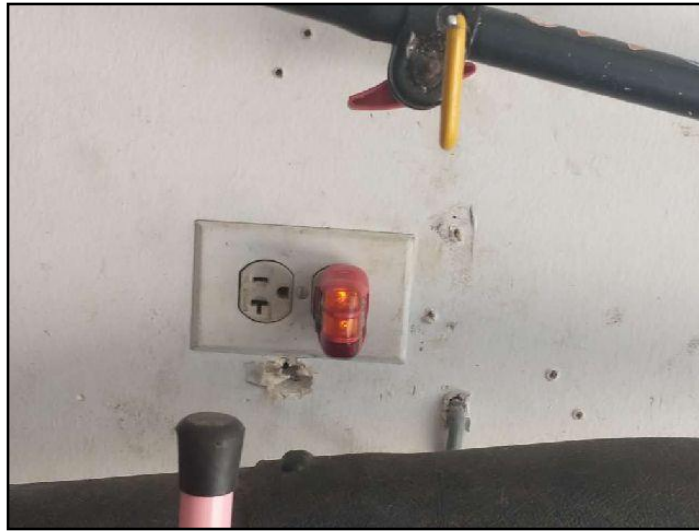
13. Condition: • [GFCI/GFI needed \(Ground Fault Circuit Interrupter\)](#)

GFCI/GFI needed (Ground Fault Circuit...

Task: consult a qualified, licensed electrician for repairs

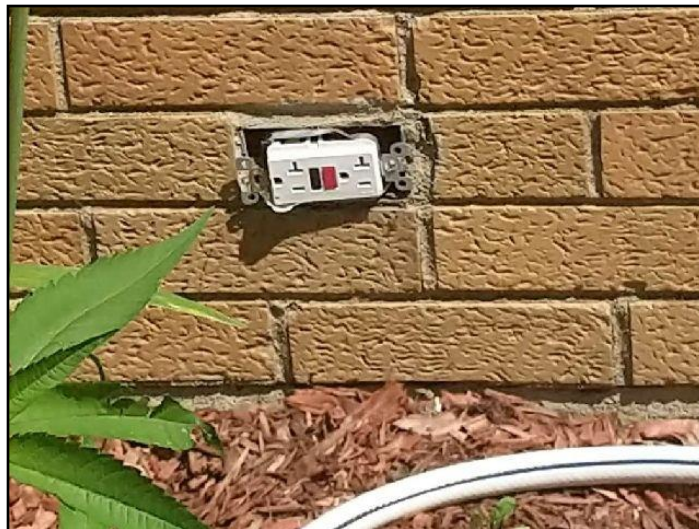
14. Condition: • [Test faulty on GFCI/GFI \(Ground Fault Circuit Interrupter\)](#)

No cover/ Faulty

Task: Consult a qualified, licensed electrician for repairs

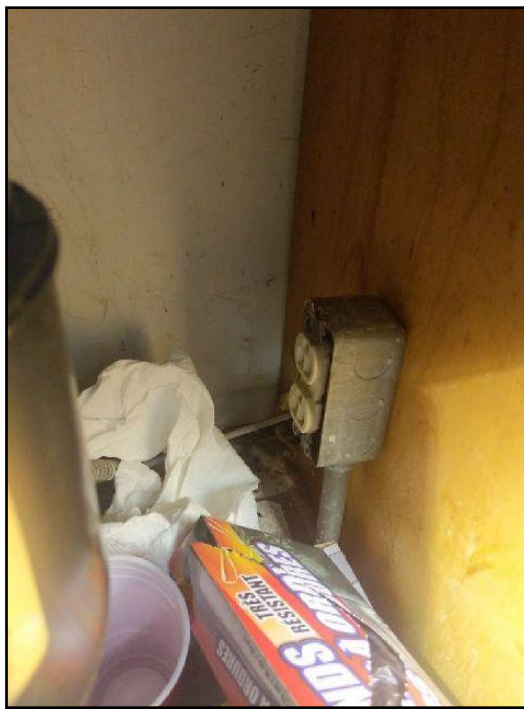
Missing or loose fitting plates.

Missing plate

Task: Repair

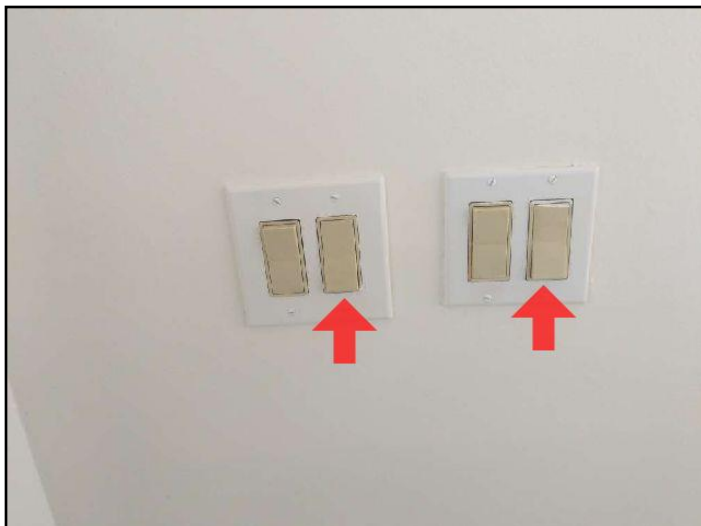
16. Condition: • [Inoperative](#)

What do they operate?

Task: Further evaluation needed

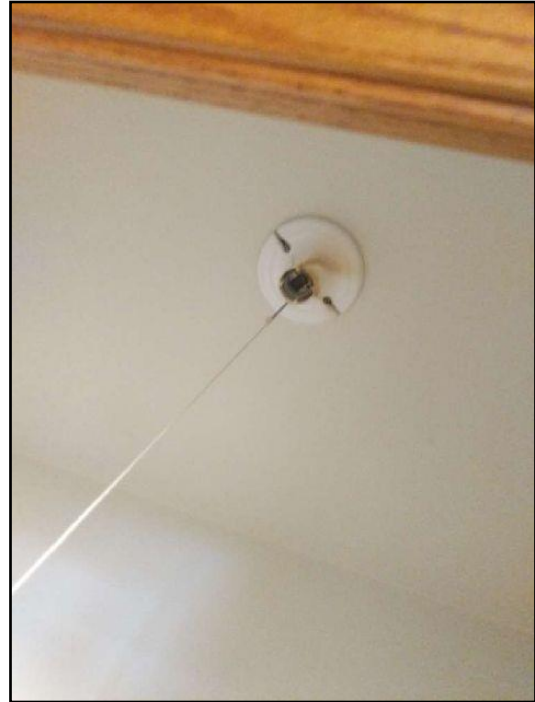
No bulb

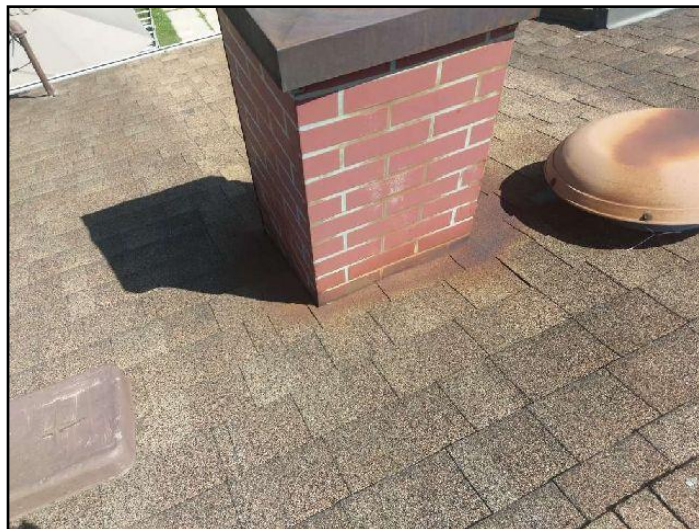
18. Condition: • The chimney, is a faux chimney. The flashing material, which protects the roof from water intrusion is not visible. Further evaluation required.

Faux chimney

Task: Consult a qualified, licensed roofer for further evaluation and repairs as needed

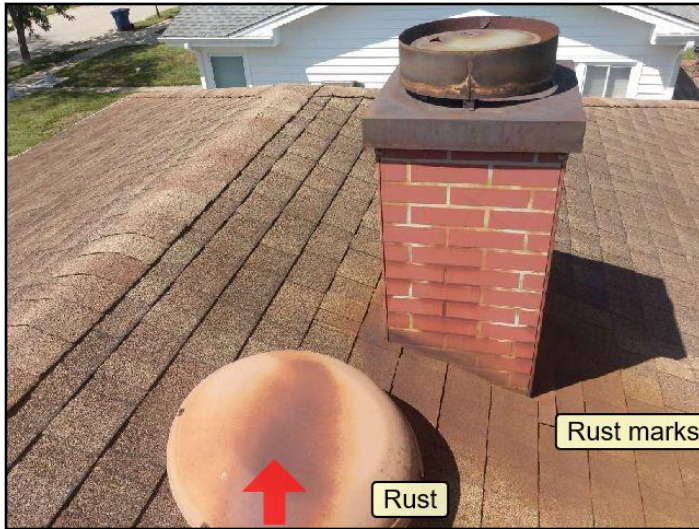
19. Condition: • Rust can be found around the roof of the faux chimney. The vent, near it is rusting. Finally, the top of the chimney has a hole and rust.

Rust

Task: Consult a qualified, licensed contractor for repairs

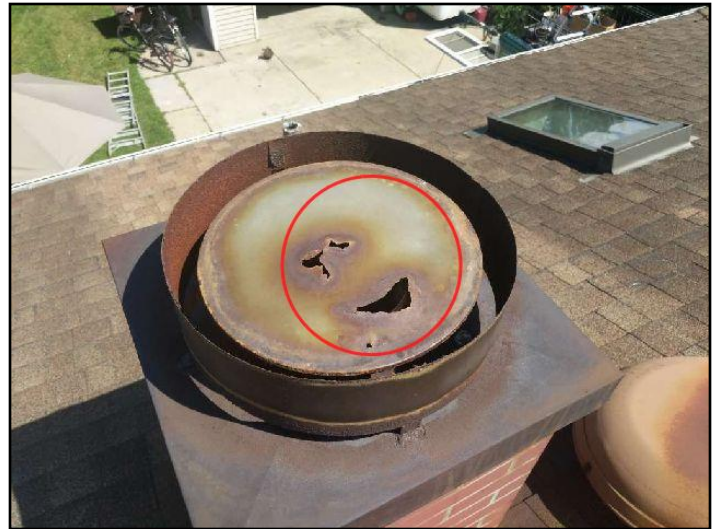
Hole in top of faux chimney

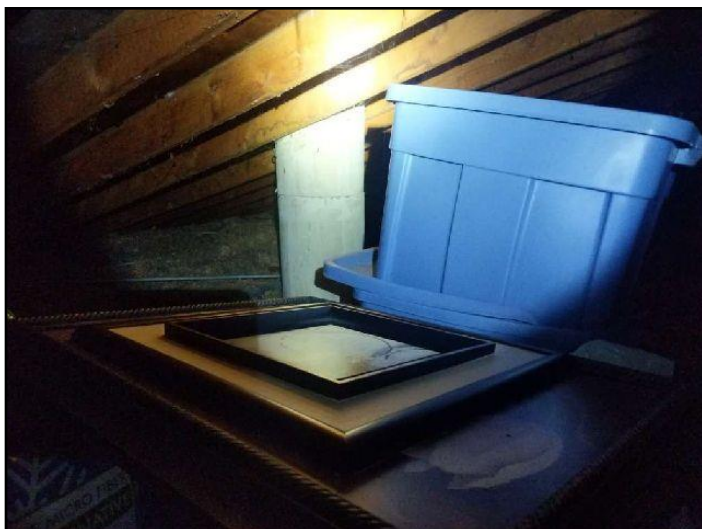
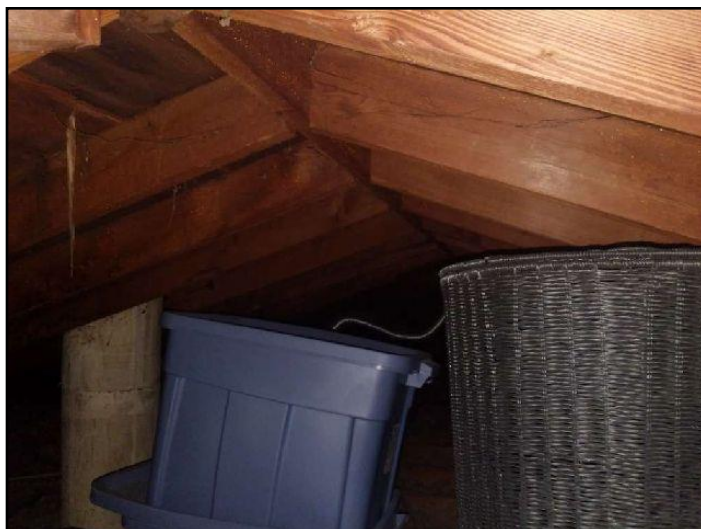
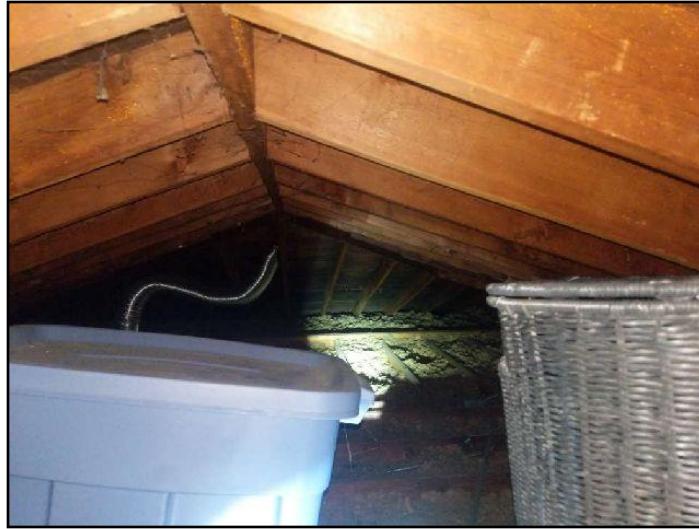
Piles of storage exists around the attic hatch, no access, limited inspection

Attic storage

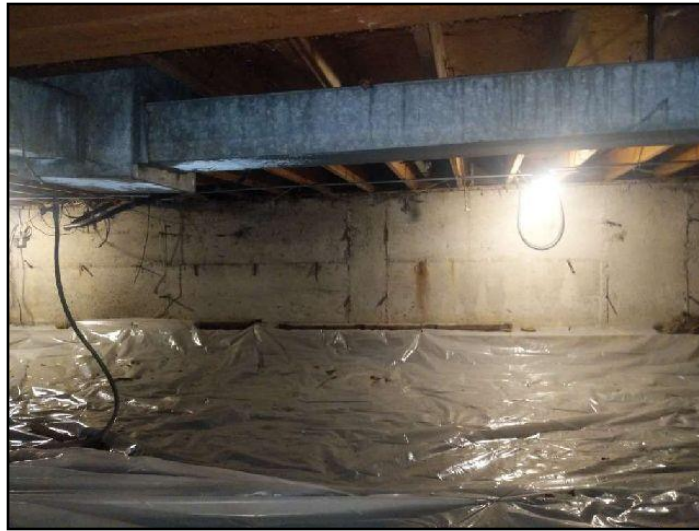
20. Condition: • Recommend insulating water pipes and supply vents in the crawlspace

Uninsulated supply duct

Task: Consult a qualified, licensed insulation contractor for repairs

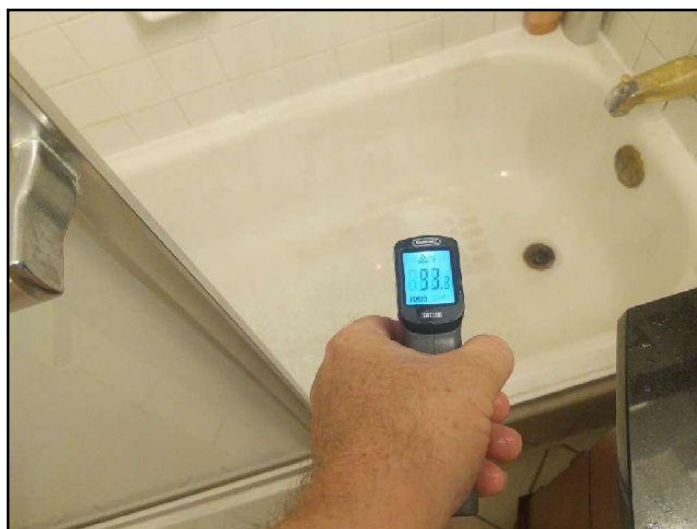
• Less than 100° F

93 F degrees

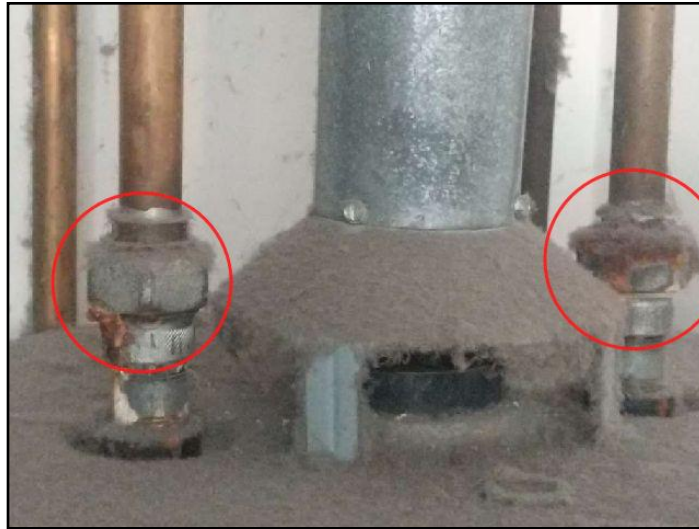
26. Condition: • [Rust](#)

Rust

Task: Consult a qualified, licensed plumber for repairs

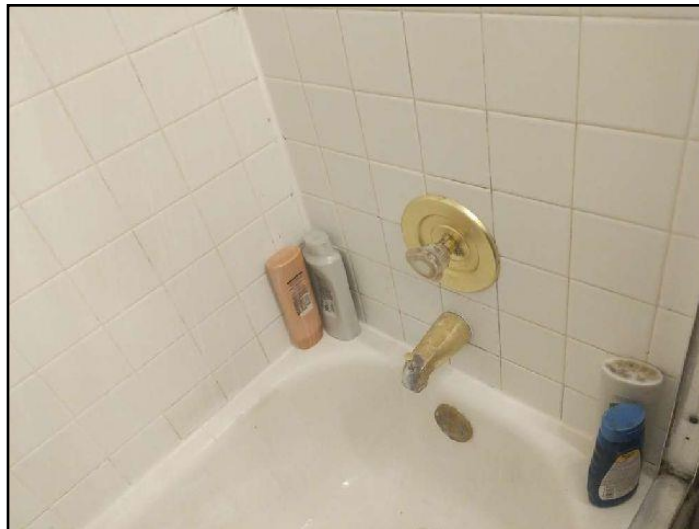
27. Condition: • Hot and cold is reversed

Hot/cold reversed

Task: Consult a qualified, licensed plumber for repairs

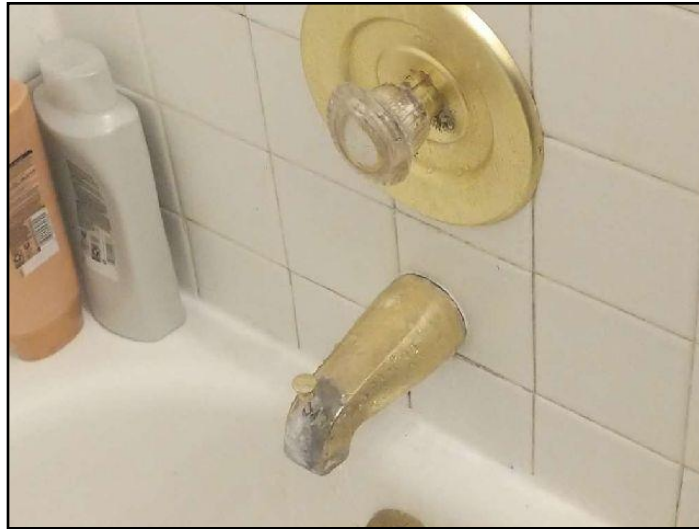
28. Condition: • The gold plating on the fixtures have been tarnished/damaged.

Gold plating less

Task: Replace

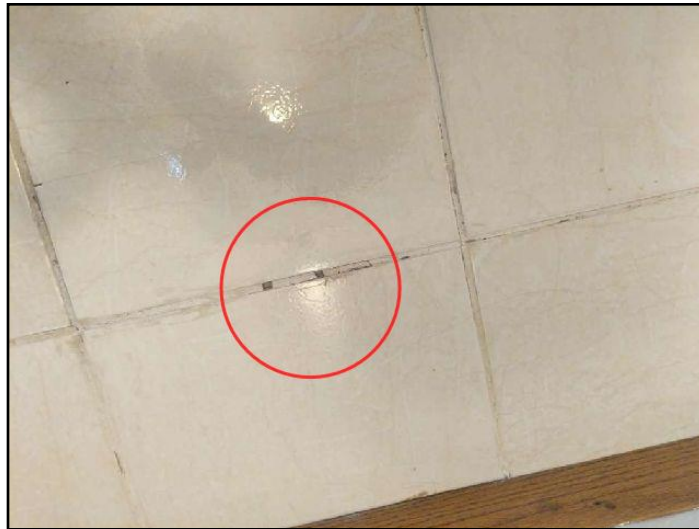
33. Condition: • The floor appears to be ceramic. The grout is cracking/loose

Missing Grout

Task: Consult a qualified, licensed floor contractor for repairs

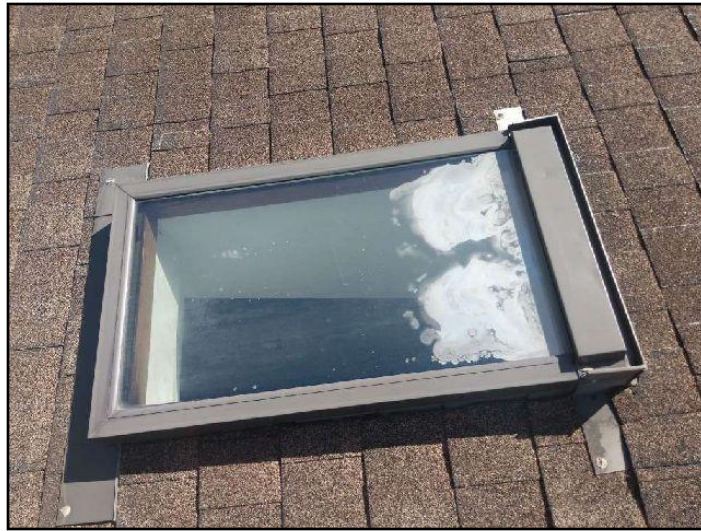
34. Condition: • [Lost seal on double or triple glazing](#)

Thermo seal broken

Task: Consult a qualified, licensed window contractor for repairs

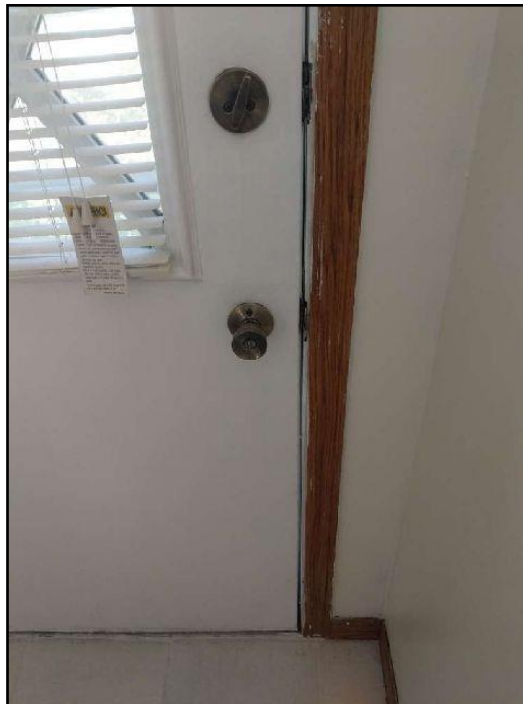
35. Condition: • [Weatherstripping missing or ineffective](#)

Light through door

Task: Consult a qualified, licensed door contractor for repairs

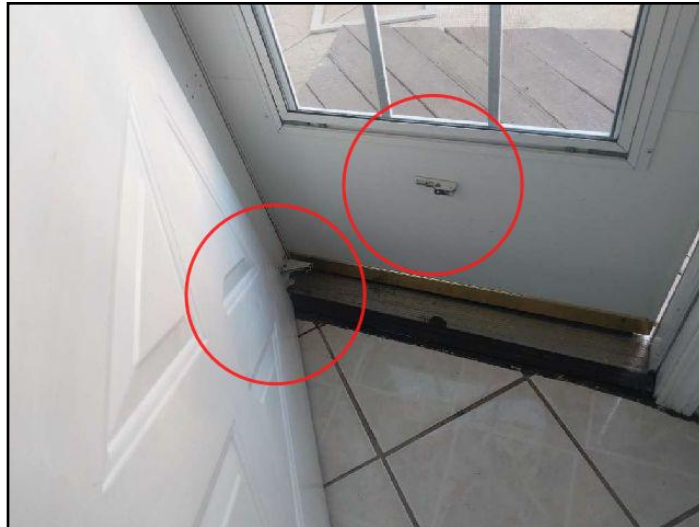
Storm door re tractor missing.

Re tractor missing

Task: Consult a qualified, licensed door contractor for repairs

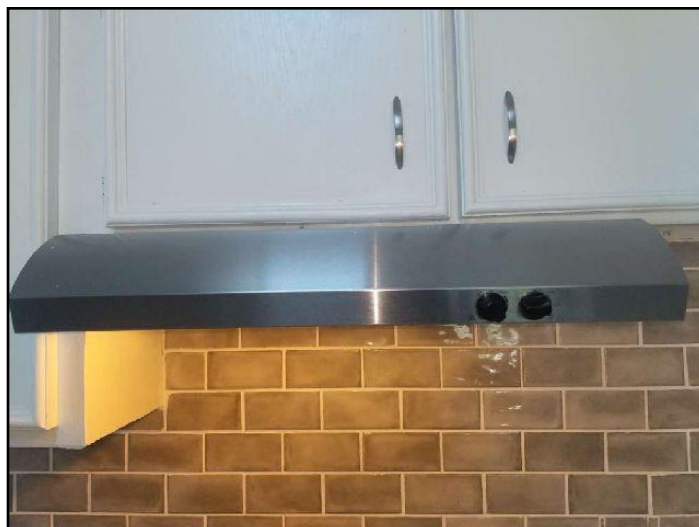
37. Condition: • [Inoperative](#)

Exhaust fan inoperative

Task: Consult a qualified, licensed appliance contractor for repairs

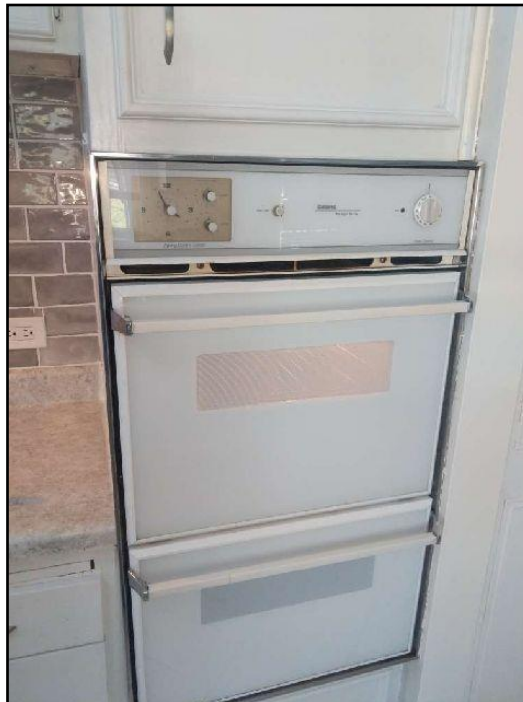
38. Condition: • Inoperative

Inoperative

Task: Consult a qualified, licensed appliance contractor to replace

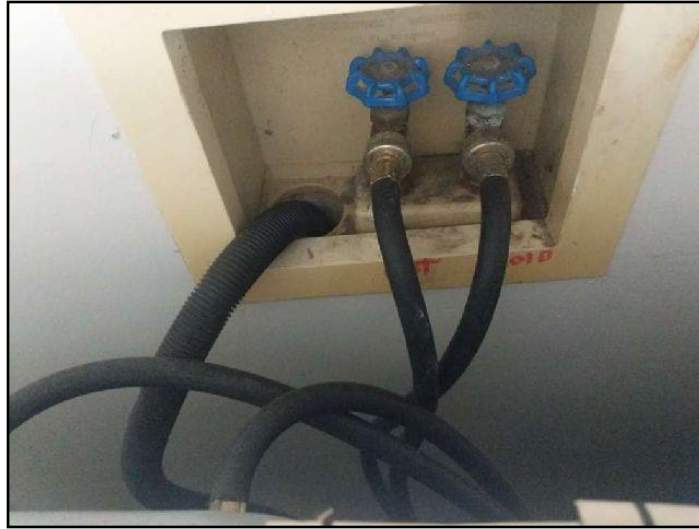
39. Condition: • Old/Low quality hoses

Old/Low quality hoses

Recommend steel braided type.

Task: Consult a qualified, licensed appliance contractor for repairs

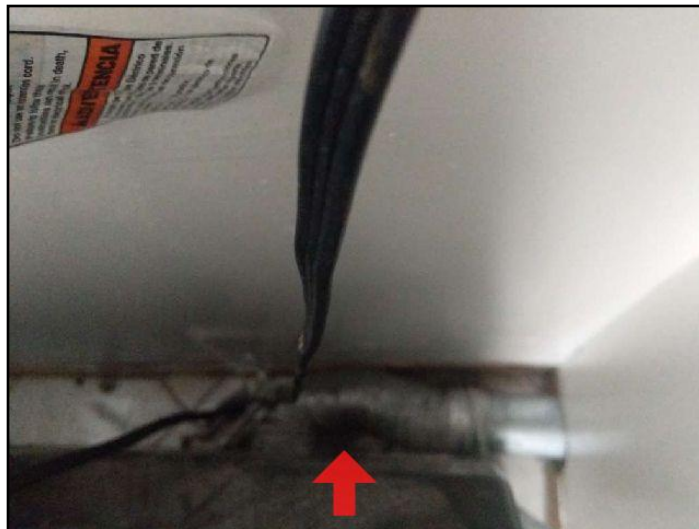
40. Condition: • Dryer vent material not smooth wall

Dryer vent material not smooth wall

Task: Consult a qualified, licensed appliance contractor for repairs
